TECHNICAL UPDATE

SAMPLE(s): "SBR 1 ML", "SBR 1 Foam", "SBR 2 ML" and "SBR 2 Foam"

Problem(s): Identify cause of foam and make recommendations.

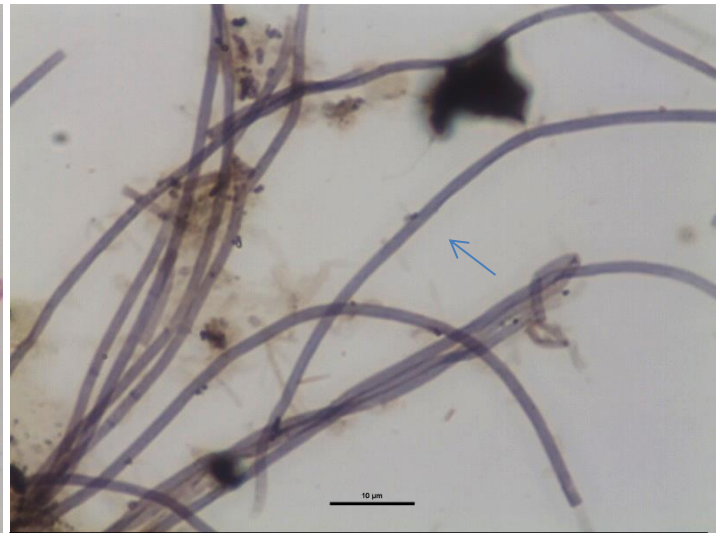
Figure 8-SBR 2 ML Neisser stained and viewed with 1000X magnification showing Neisser positive sheaths of type 0092 (arrow).

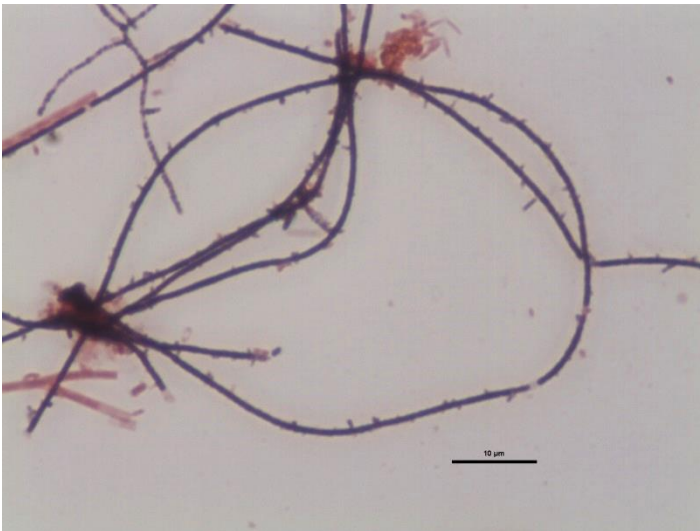
Figure 11-SBR 2 ML Gram stained and viewed with 1000X magnification showing Gram positive, unbranched filaments of *Microthrix parvicella* (purple filaments in center).

Rank	Filament	Abundance	Cause
1	Type 0092	High	Low F:M, high simple organic acids.
2	Nocardioforms	High	FOG, long MCRT
3	<i>Microthrix</i>	Medium	FOG, cold temperature
4	Type 0675/0041	Low	Low F:M
